# Final Fluvial Geomorphological Assessment Report – Holland River Crossings

Highway 400 to Highway 404 Link (Bradford Bypass)

Ontario Ministry of Transportation

August 25, 2023

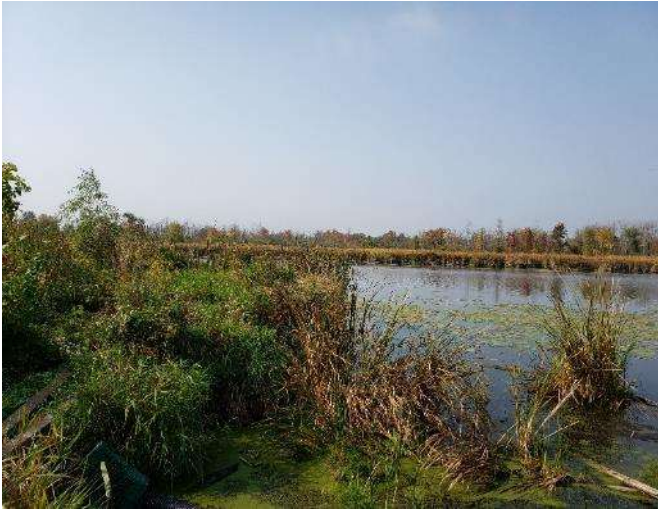
**Photograph 1.** ↑

West branch of Holland River. Looking upstream from right bank, west of Hochreiter Rd. Taken approximately 2km downstream of the Queensville Sideroad West crossing

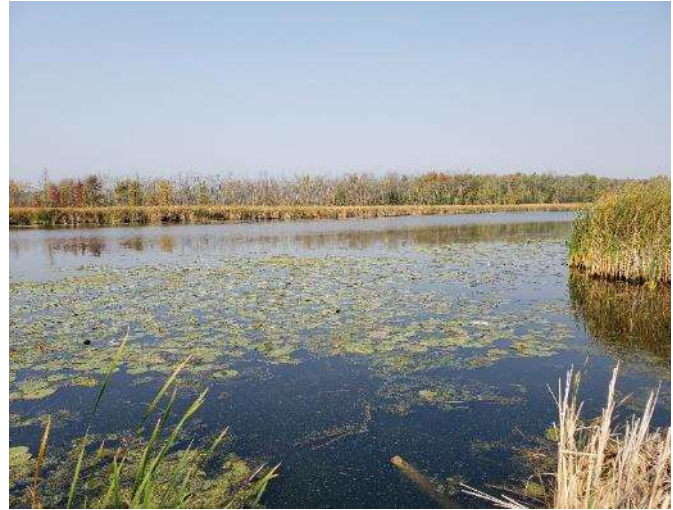
**Photograph 2.** ↑

West branch of Holland River. Looking downstream from right bank, west of Hochreiter Rd. Taken approximately 2km downstream of the Queensville Sideroad West crossing

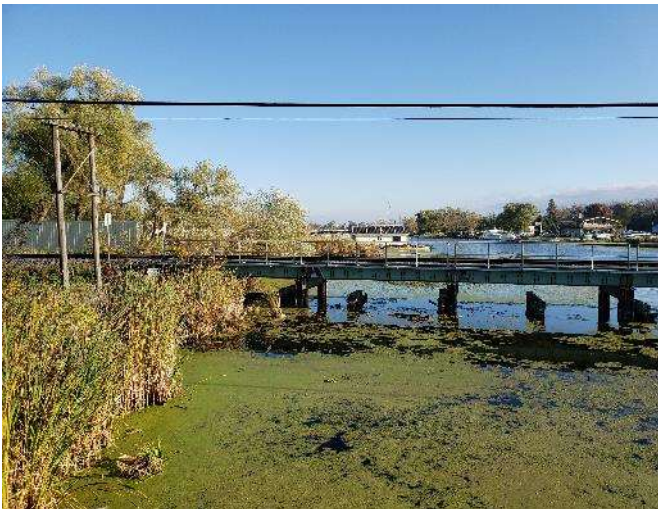
**Photograph 3.** ↑

Bridge crossing along West branch of Holland River. Looking south towards bridge

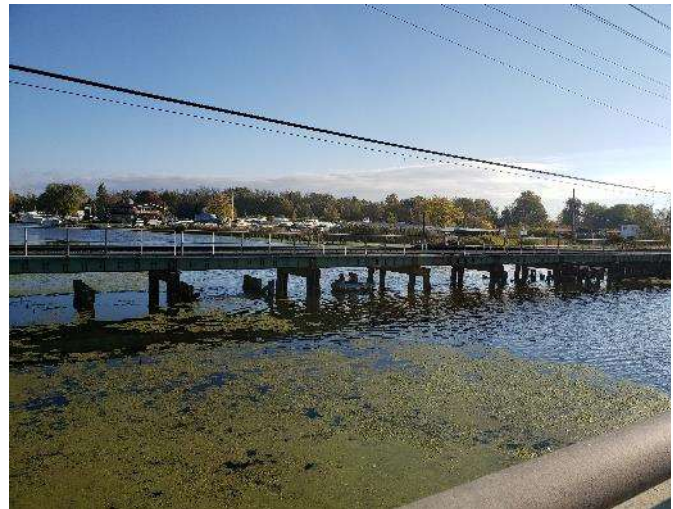
**Photograph 4.** ↑

Bridge crossing along West branch of Holland River. Looking south towards bridge

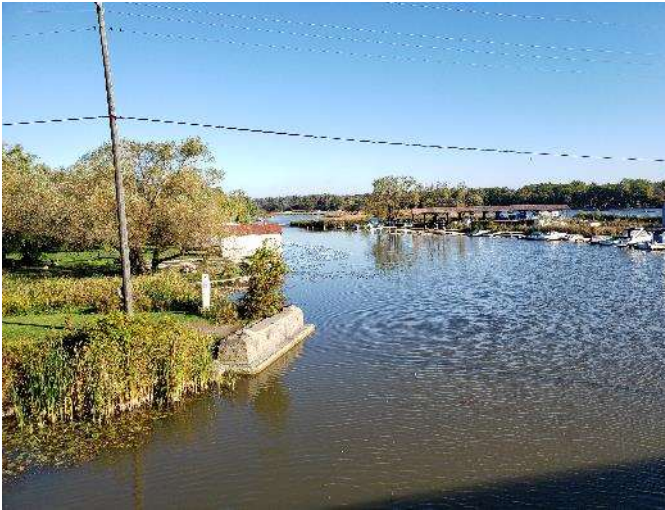
**Photograph 51.** ↑

Holland River East Branch, looking downstream from Queensville Sideroad West. Boat marinas located on right and left banks.

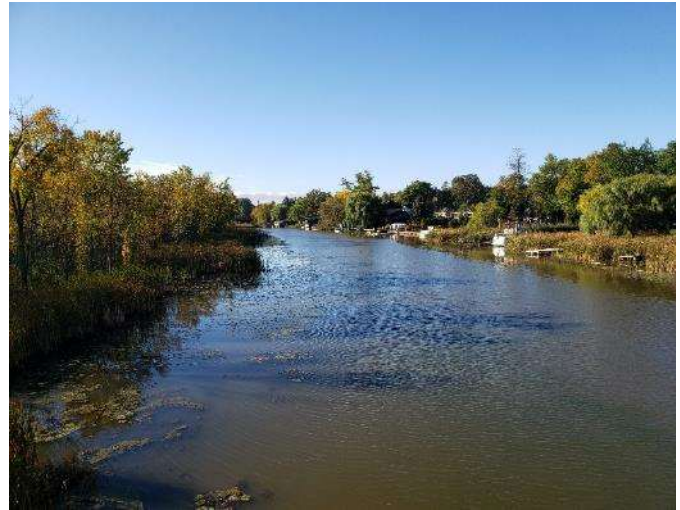
**Photograph 6.** ↑

Holland River East Branch, looking upstream from Queensville Sideroad West. Boat marinas located on left bank.

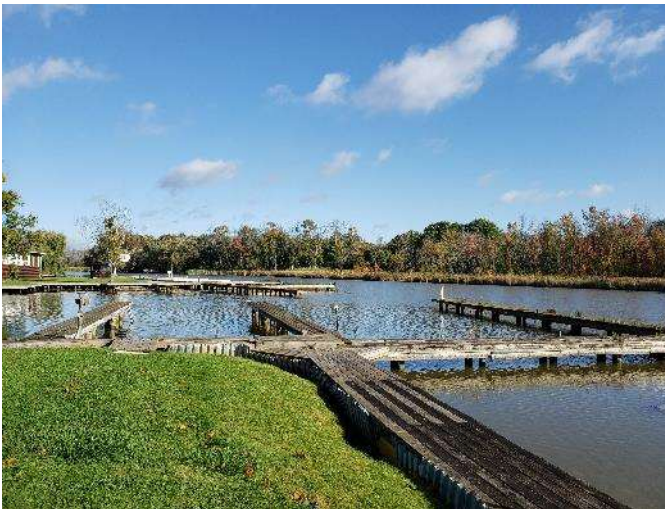
**Photograph 72.** ↑

Holland River East Branch, looking at the docks set up near Albert's marina approximately 1.4km downstream from the Queensville Sideroad West crossing

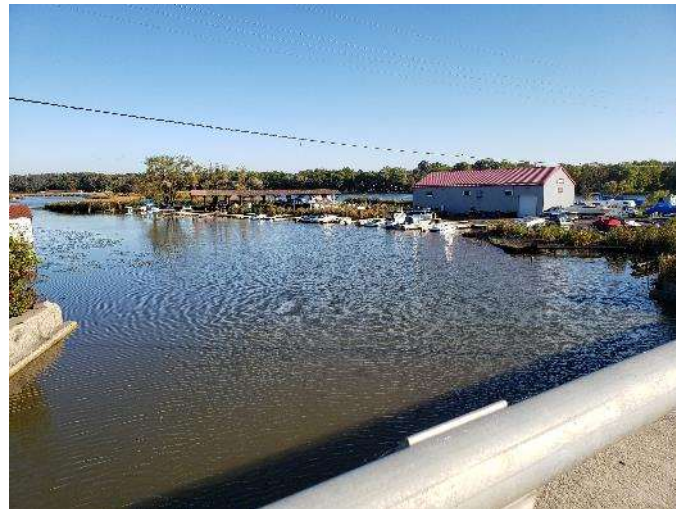
**Photograph 83.** ↑

Holland River East Branch, looking across the bridge that spans Queensville Sideroad West
