Final Fish and Fish Habitat Existing Conditions and Impact Assessment Report

Highway 400 to Highway 404 Link (Bradford Bypass)

Ontario Ministry of Transportation

August 22, 2023

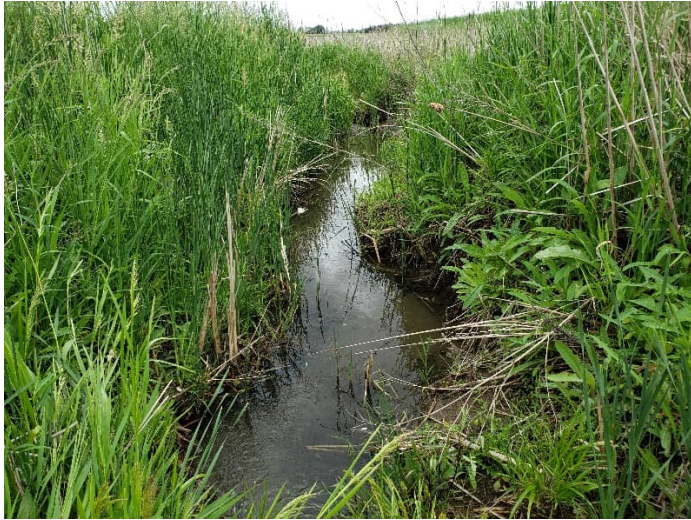
Photograph 5. ↑

C10-A-B, June 2022. Looking upstream (west) towards the culvert outlet. Clean gravel and pebbles were observed in the riffle section.

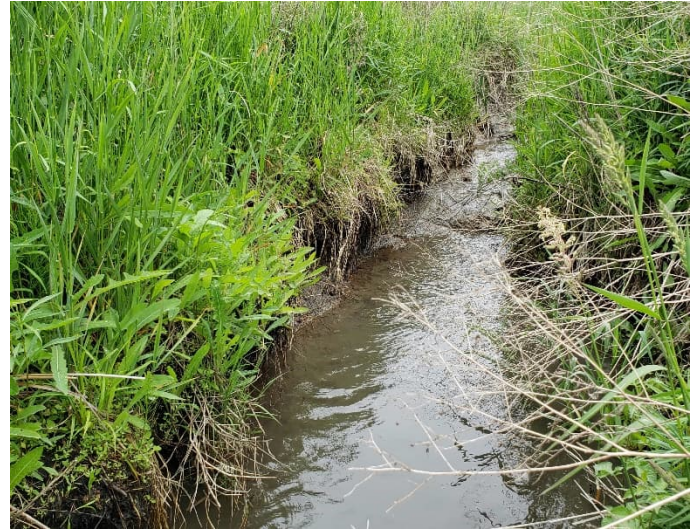
Photograph 6. ↑

C10-A-B, June 2022. Looking downstream (east) from the highway ROW. ~~Vulnerable banks and some~~ Some evidence of erosion was observed at the time of inspection.

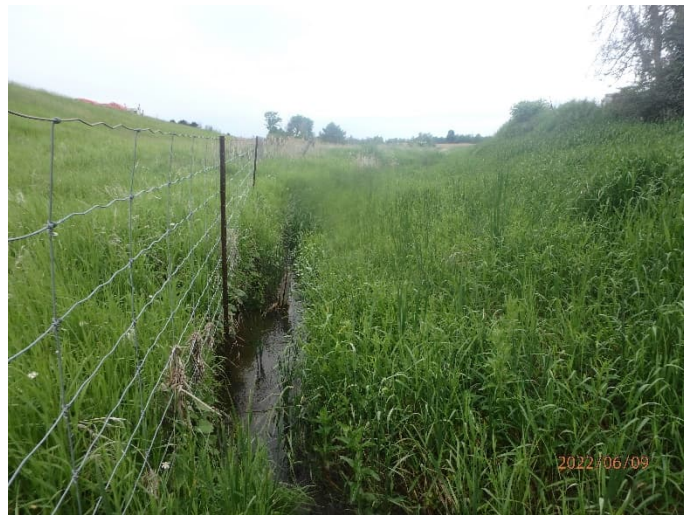
Photograph 7. ↑

C10-A-B, June 2022. Looking upstream (west) from the highway ROW. ~~Vulnerable banks and some~~ Some evidence of erosion was observed at the time of inspection.

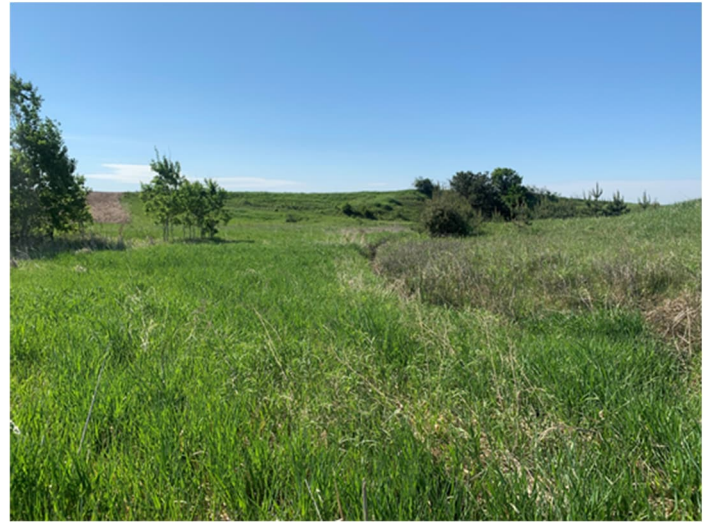
Photograph 10. ↑

C10-A-1, June 2021. Looking upstream (north) at upstream ZDA. Meandering channel through grassed meadow.

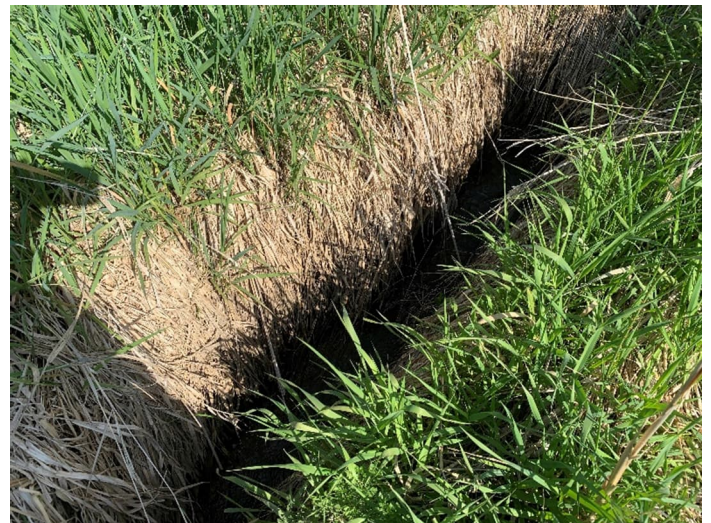
Photograph 12. ↑

C10-A-1, June 2021. Looking east from channel at riparian grasses. Agricultural fields further east 30+ m from channel.

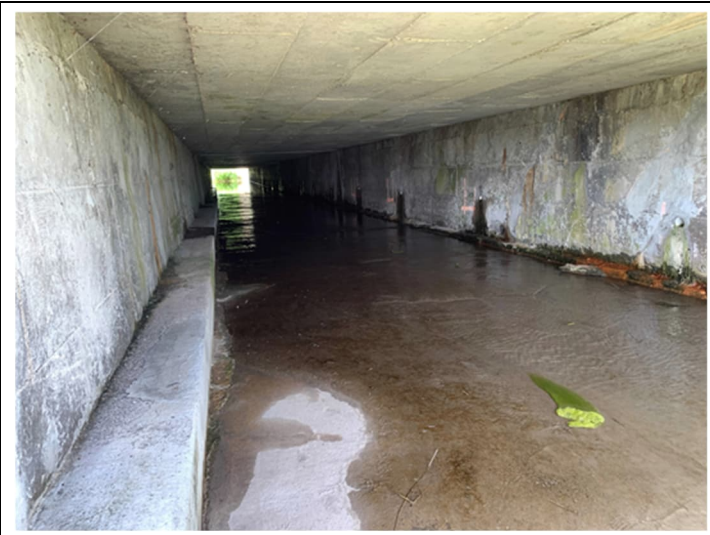
C10-A-4, June 2021. Culvert inlet on east side of Highway 400, looking west.

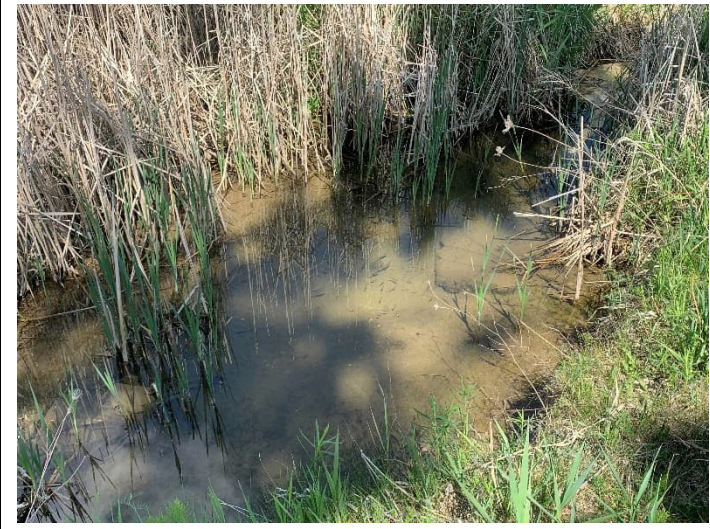
Photograph 23. ↑
C10-A-4, June 2021. Pool at culvert inlet in upstream ZDA.

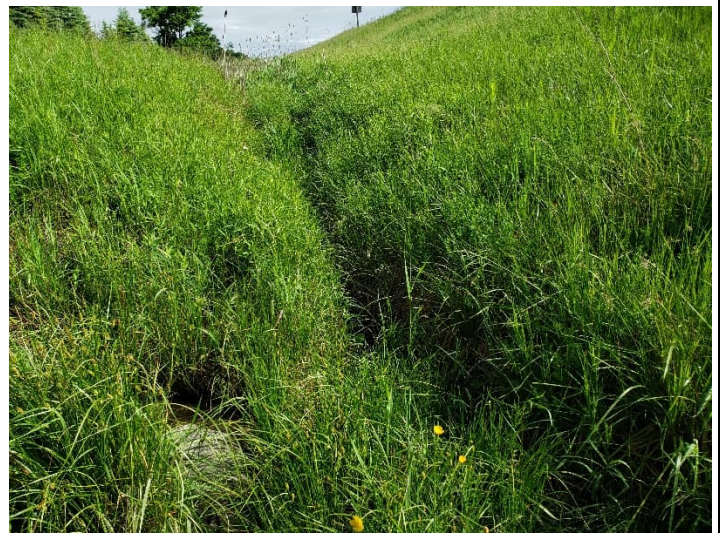
Photograph 31. ↑
C10-A-6, June 2022. Looking downstream (east) at Hwy 400 Culvert inlet. The concrete bottom of the culvert appears to have been eroded away.

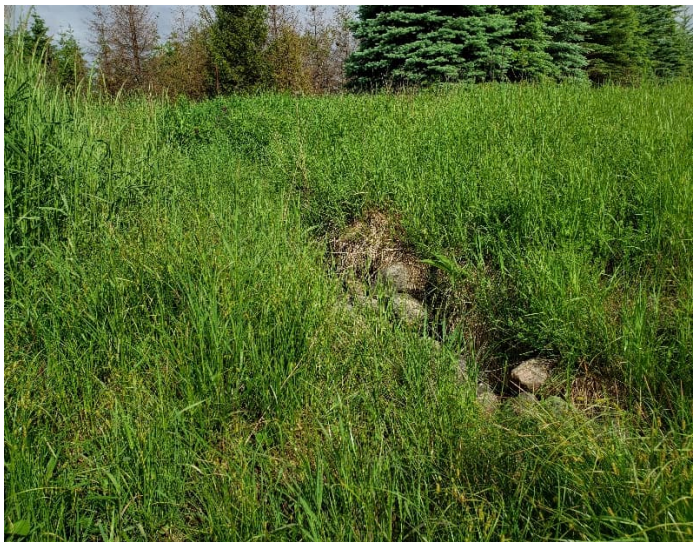
Photograph 32. ↑
C10-A-6, June 2022. Looking upstream (north) at the highway drainage channel. Terrestrial grasses and some cattails grew throughout the channel.
